SOIL INVESTIGATION AND GEOTECHNICAL STUDY REPORT FOR MARIDI COUNTY STRUCTURES

***GEO-TECHNICAL REPORT FOR
CONSTRUCTIONS IN MARIDI COUNTY,
WESTERN EQUATORIAL, SOUTH SUDAN***

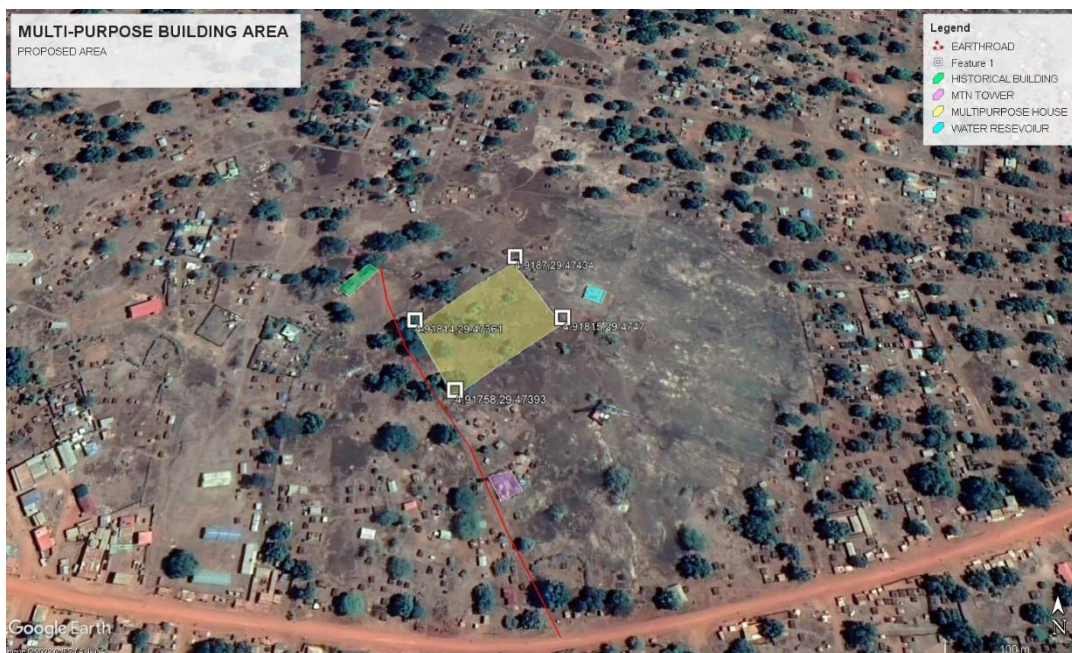
Fig 2. 1: Multi-business and training centre Maridi Central, Maridi

The general soil type of the area is loam soil having black loam colour up-to a depth of 40 cm and then shifts to red alluvial soil.

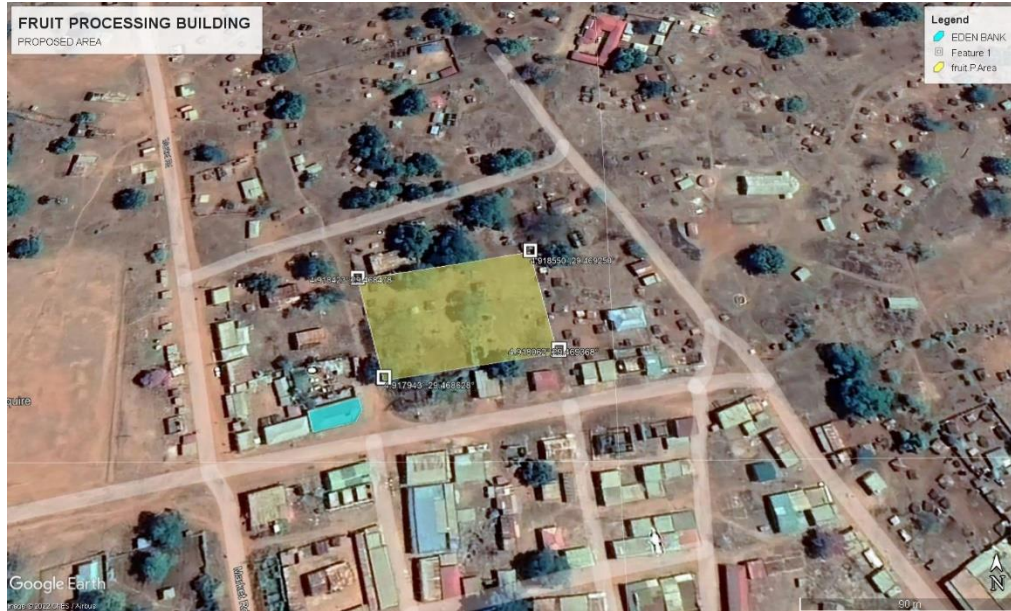
Fig 2.2: Fruit processing factory, Maridi Central, Maridi

The land size: 30m by 25m giving total area as 750m². This facility is located near Eden bank almost near the Maridi, Town square. The site is located within the Maridi town and hence no need for access road construction or any work of bush clearing. The general soil type of the area is loam soil having black loam colour up-to a depth of 40 cm and then shifts to red alluvial soil.

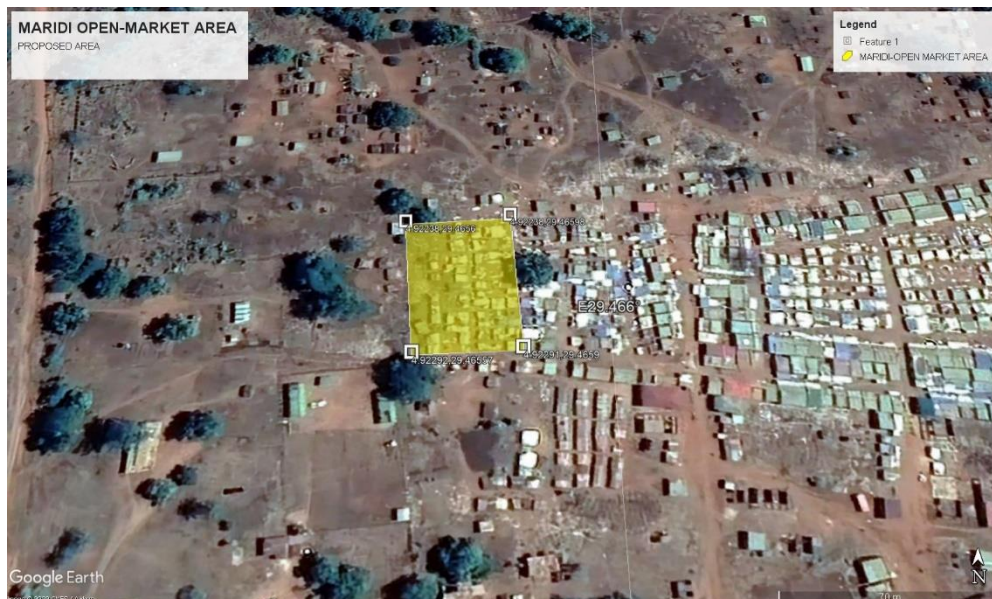
Fig 2.3: Open market center, Maridi Central, Maridi

The land size: 40m by 60m giving total area as 2400m². The site is located to the north eastern part of the town and has very good mobilization and transportation access. The general soil type of the area is loam soil having black loam colour up-to a depth of 40 cm and then shifts to red alluvial soil.

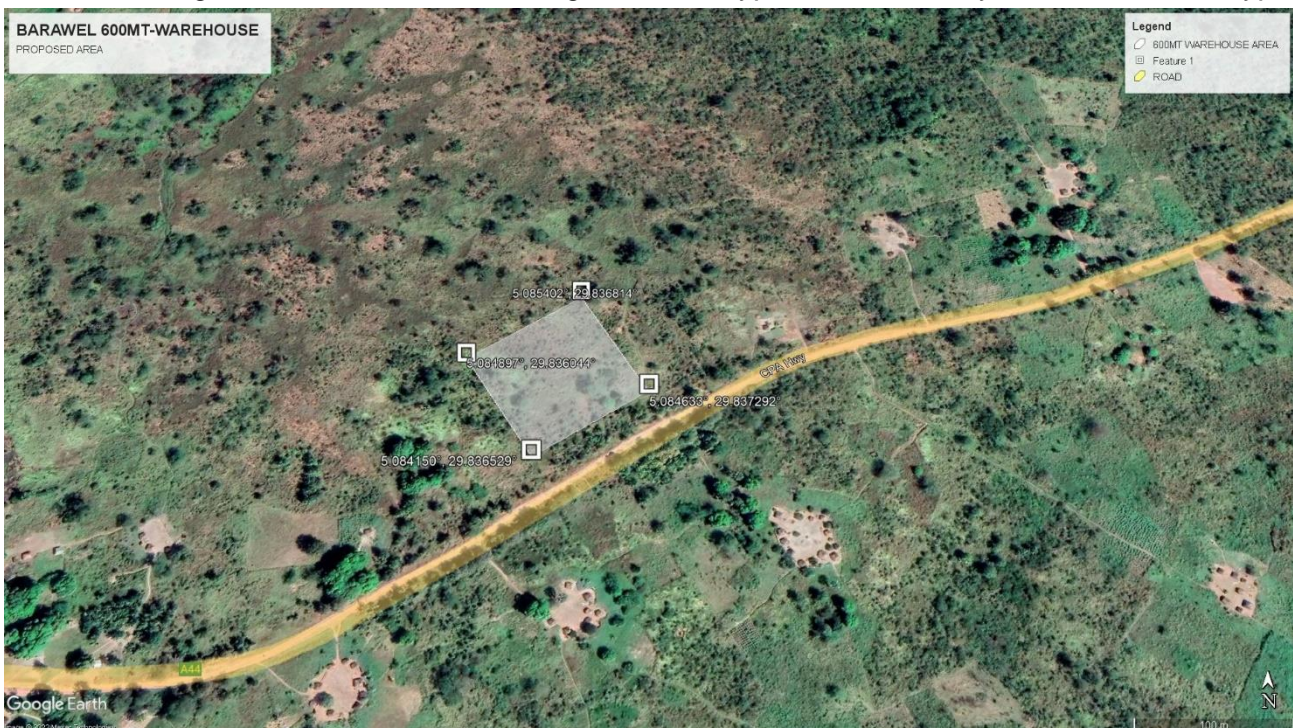
Fig 2.4: 600MT Warehouse, Barawel, Maridi

The land size:100m by 100m giving total area as 10,000m². Located on the east-side of the road from Maridi to Juba, Barawel under payam of Mambe is 45 km away from maridi and 15km away from Mambe. The proposed area will need bush clearing at the beginning of the construction stage but there is no problem of access from the main Road, however the road has incurred erosion due to continuous and high amounts of rainfall. The general soil type is sedimentary soil of river sand type.

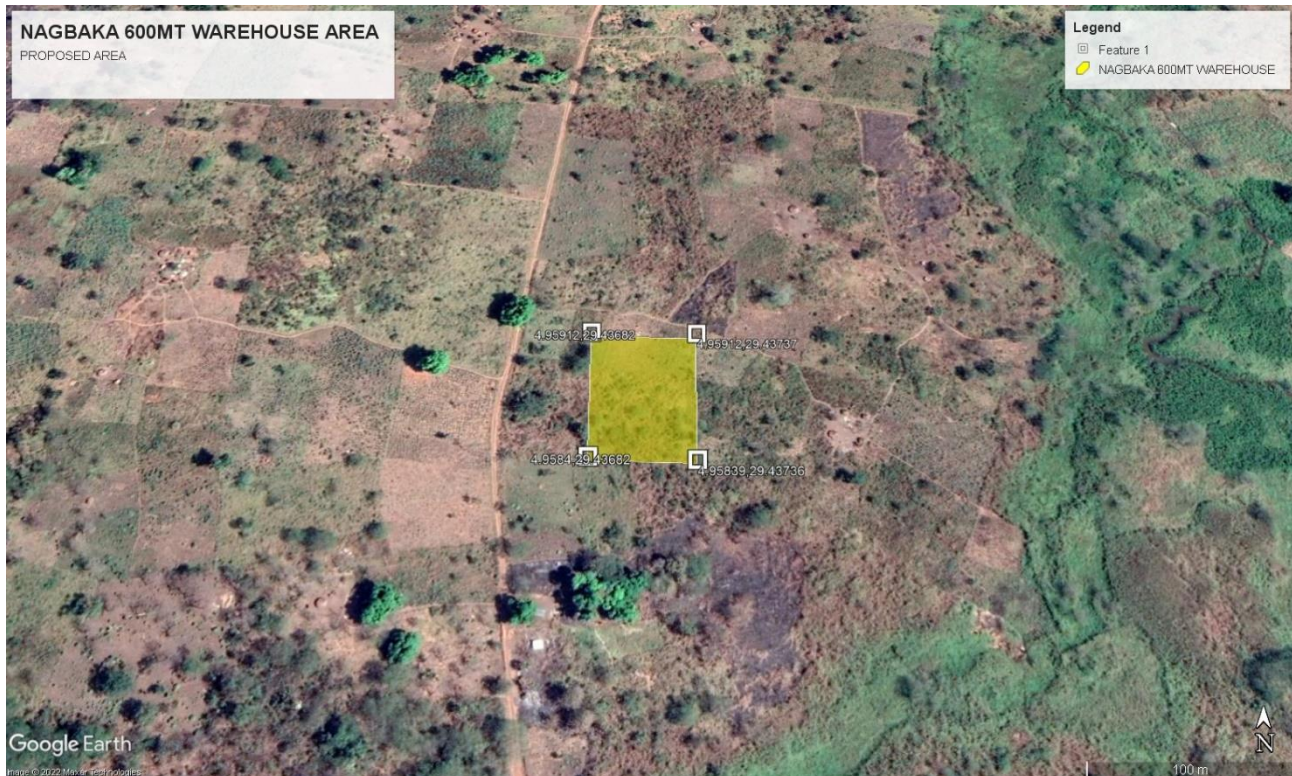
Fig 2.5: 600MT Warehouse, Nagbaka, Maridi

The land size :80m by 60 m giving total area of 4800m². Located North-west at about 15 km from Maridi Central. Found on the right side of Maridi-Yambio road at least 5Km from the main road. The proposed area will need bush clearing at the during the initial stages of construction time. The general soil type of the area is loam soil having black colour up-to a depth of 40 cm and then shifts to red loam soil.

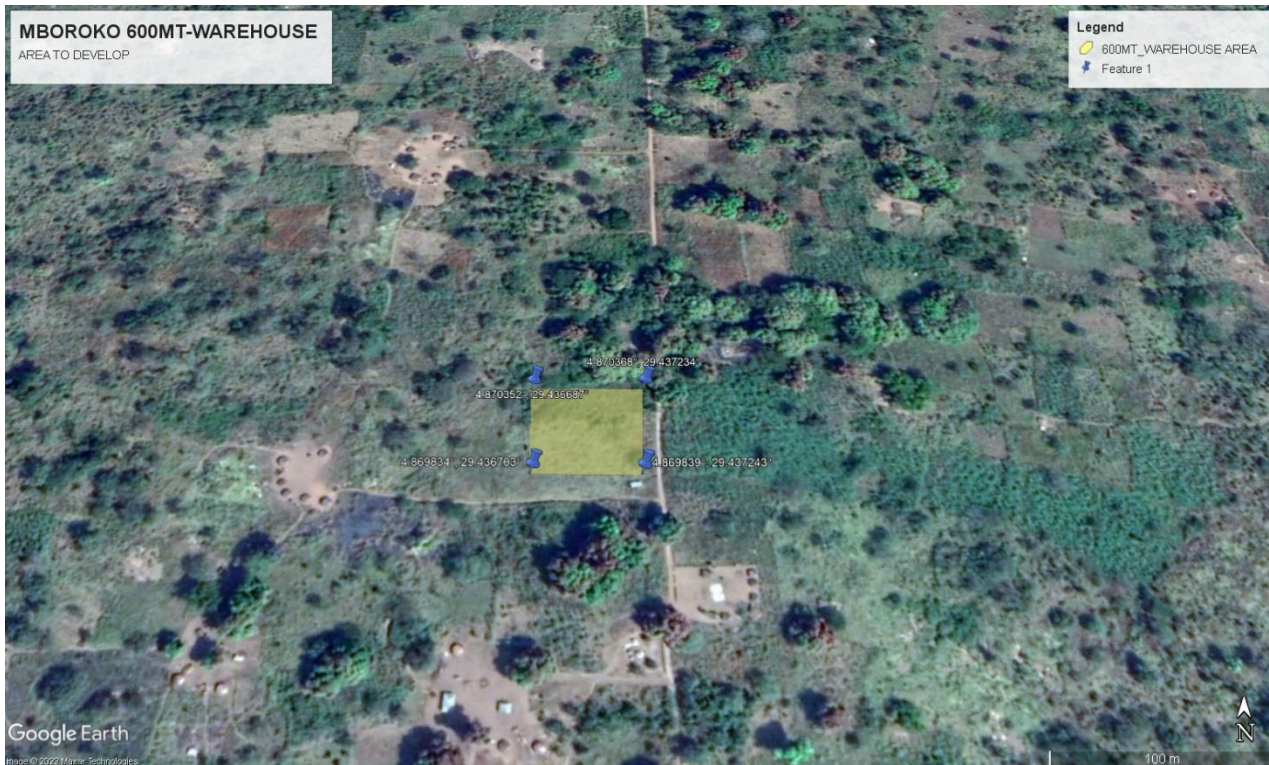
Fig 2.7: 600MT Warehouse, Burokora, Maridi

Located 5Km away from Maridi town to the North-west direction along the Maridi-Yambio Road on (left-side of the road). The road is in need of maintenance since it has faced heavy rainfall erosion and hence access is one problem. The soil is black loam soil up-to a depth of 30cm and followed by red alluvial soil layer. Ground water levels are high, and water is easily found at depths below 80cm.

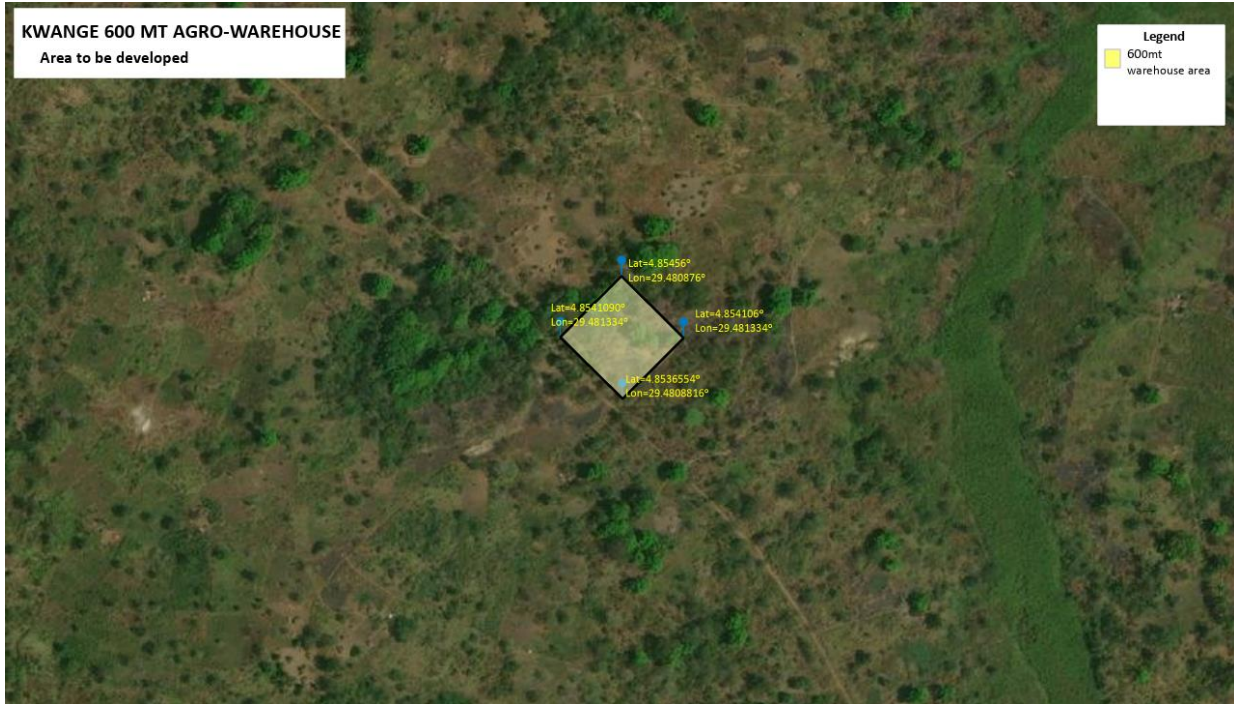
Fig 2.8: 600MT Warehouse, Kwange, Maridi

Located 7.5Km away from Maridi town to the South direction along the Maridi-Rosolo Road on (Right-side of the road). The road is in need of maintenance since it has faced heavy rainfall erosion and hence access is one problem. The soil is black loam soil up-to a depth of 30cm and followed by red alluvial soil layer. Ground water levels are high, and water is easily found at depths below 80cm.

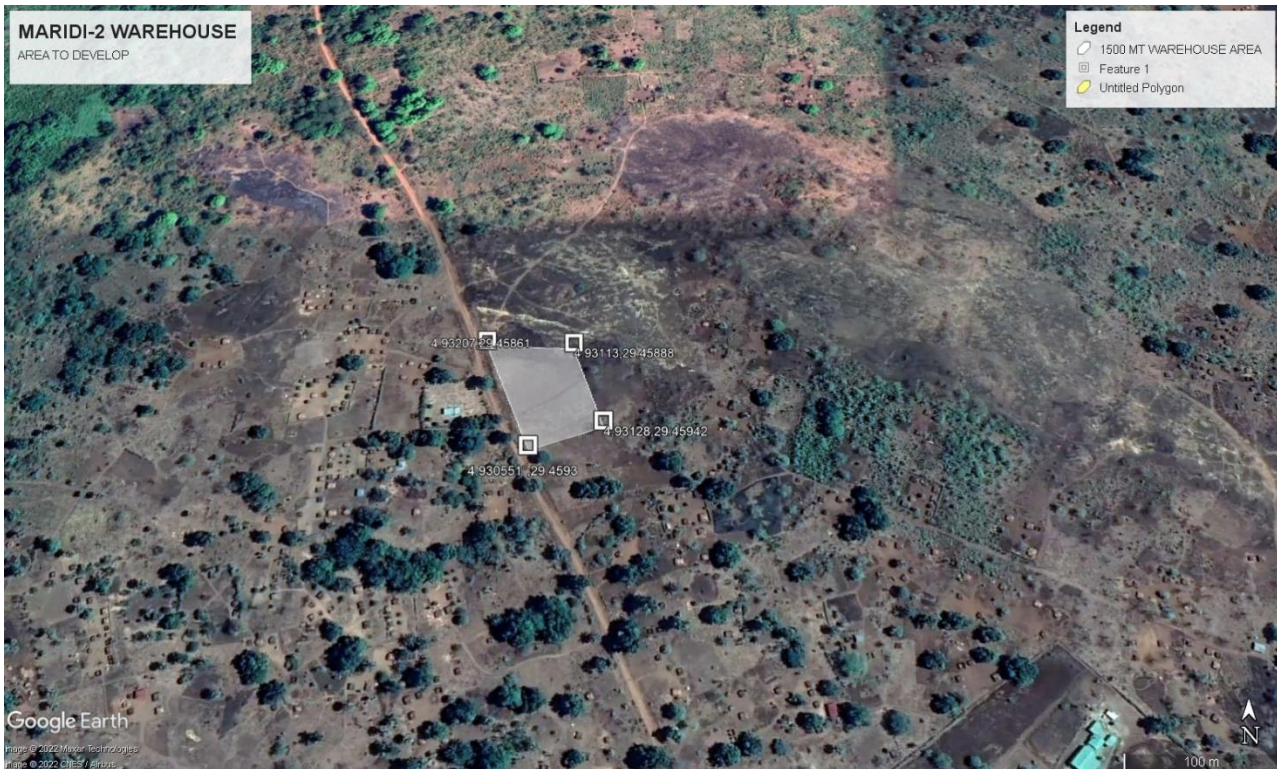
Fig 2.6: 1500MT Warehouse, Maridi-2, Maridi

The land size: 62m by 80m giving total area as 4960m². Located 20Km away from central Maridi town to the North-west direction. The road needs maintenance since it has faced heavy rainfall erosion and hence access is one problem. There is no need for bush clearing for the site. A basaltic like rock formation is visible around the area and this site is having a steep slope going northward from the proposed site. The soil around the rock formation is black loam soil up-to a depth of 30cm and followed by red alluvial soil layer. Ground water levels are high, and water is easily found at depths below 80cm.

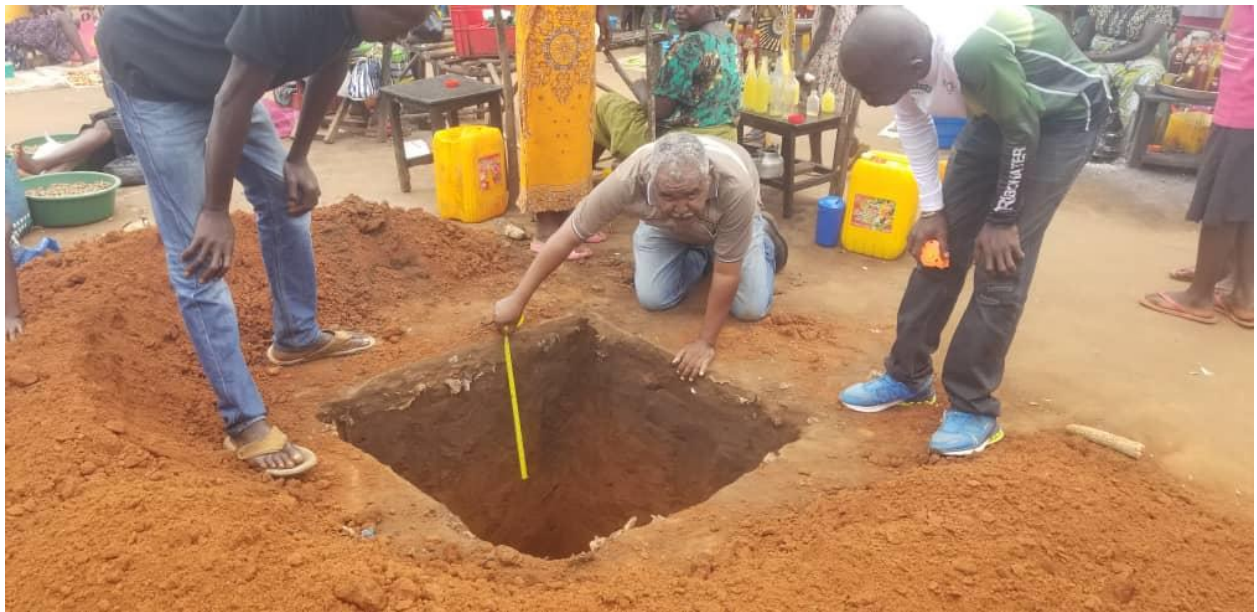
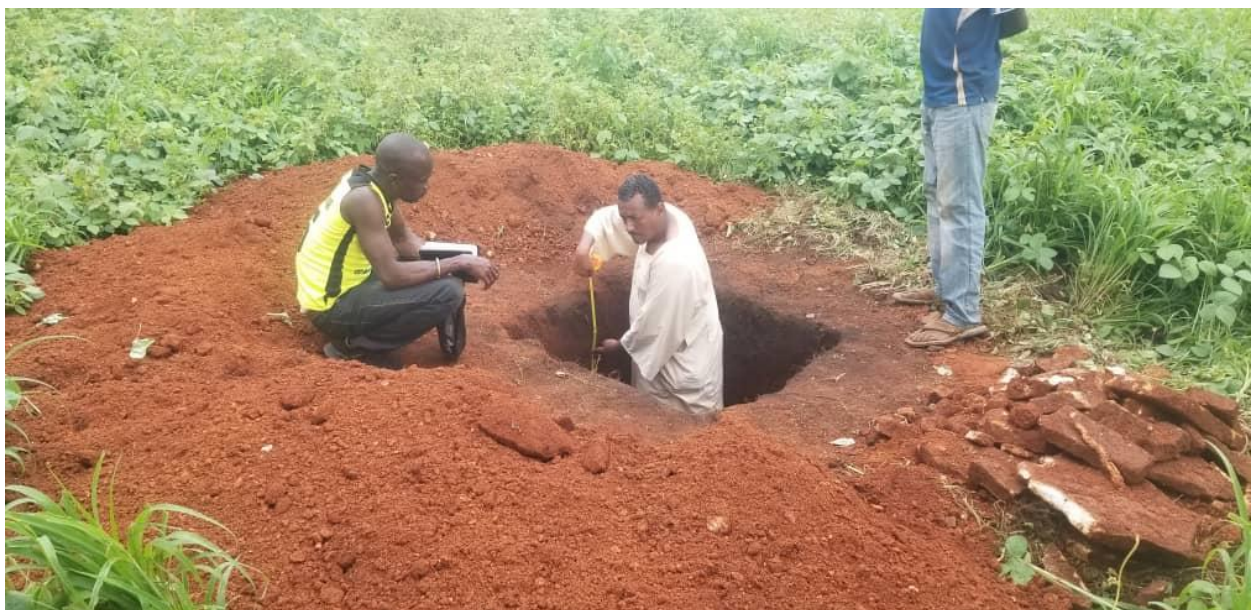
Excavation the borehole

After carrying out DCP test and analysis, below is a representation of the results as obtained from field test.

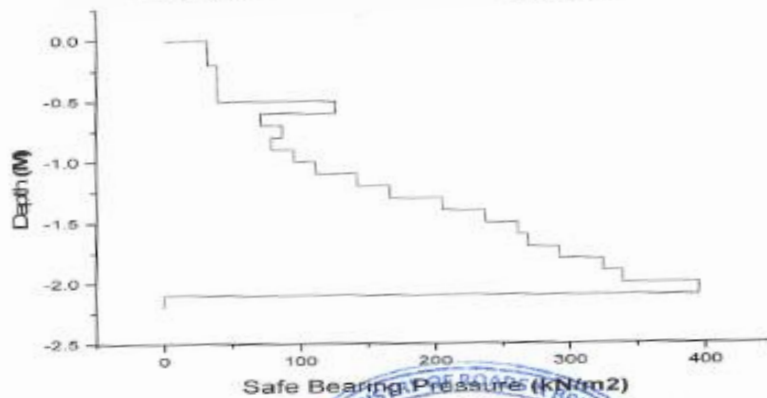
Geotechnical Investigation of Open Market Center Building, Maridi, South Sudan, Depth -2.0M (BC-339kN/m²) @ (BH No.2)

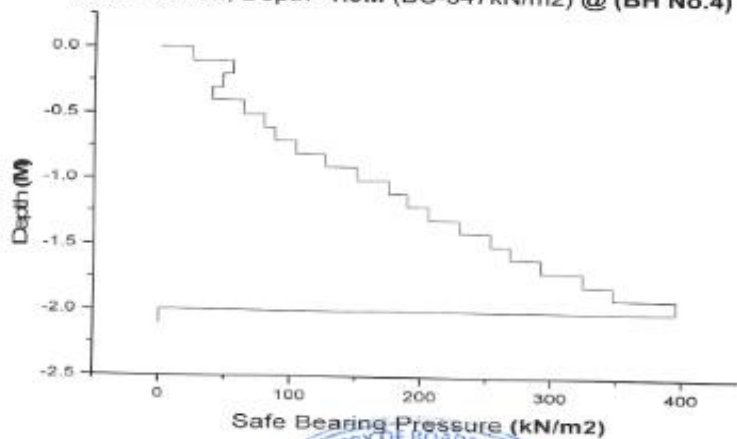
Geotechnical Investigation of Open Market Center Building, Maridi, South Sudan, Depth -1.9M (BC-347kN/m²) @ (BH No.4)

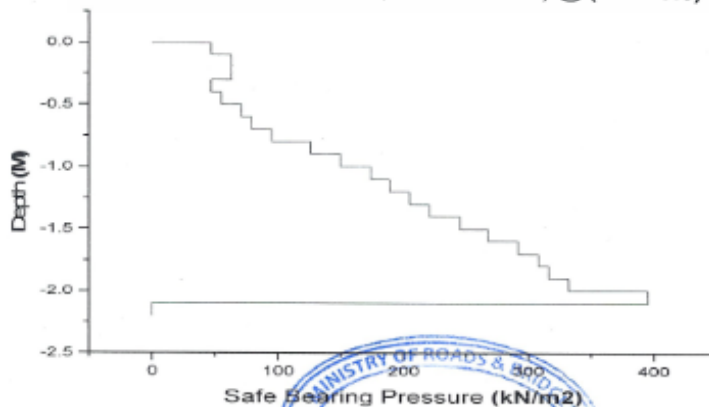
Geotechnical Investigation of Open Market Center Building, Maridi, South Sudan, Depth -2.0M (BC-332kN/m²) @ (BH No.6)
