SOIL INVESTIGATION AND GEOTECHNICAL STUDY REPORT FOR IBBA COUNTY STRUCTURES

LADDER FOR ENGINEERING AND GENERAL TRADING CO.LTD

Project :	Geotechnical Investigation of 1500MT Warehouse store Building
Location:	Ibba, South Sudan, Building Area 360 Sq.M
Property/Client :	ACTED, South Sudan
Date :	22/09/2022

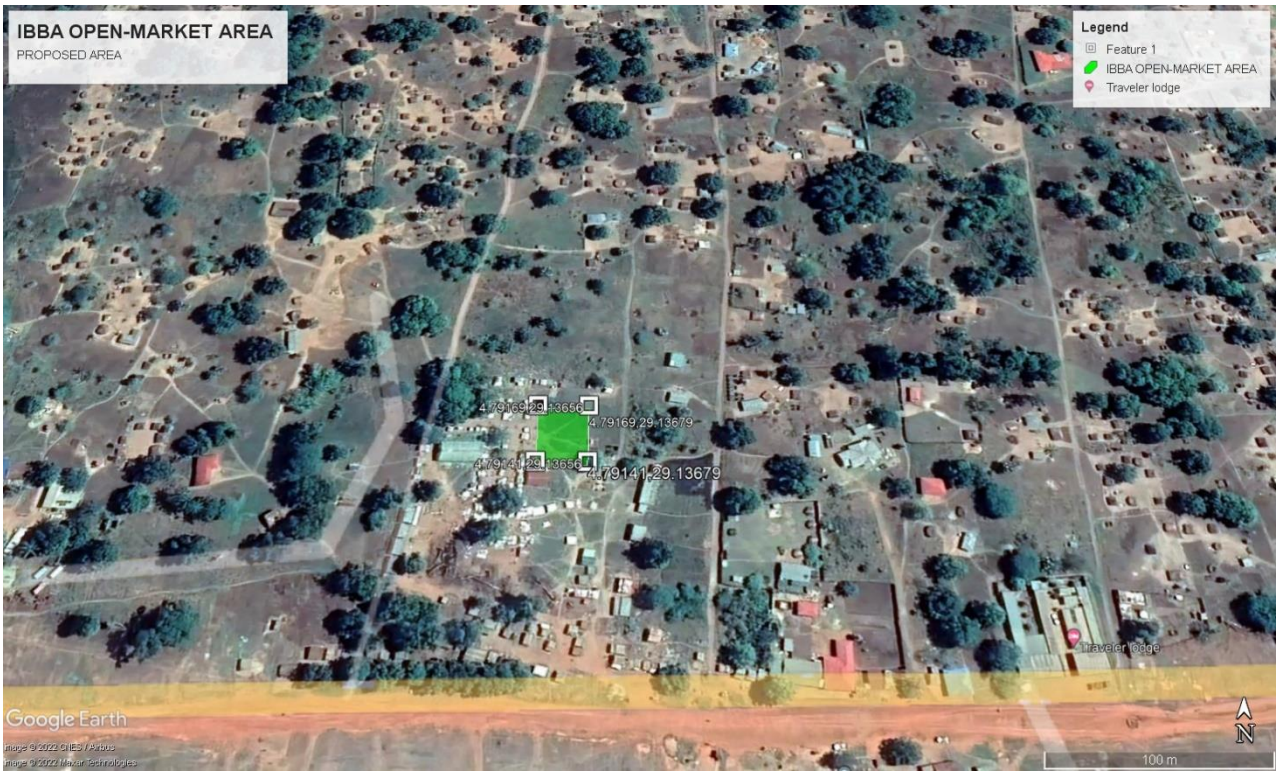
Fig 2.1 Namrabia (Ibba) Open Market Centre

The land size: 25m by 30m giving total area as 750m^2. Located at the old market place which has been out of use for reasons including insufficient ventilation and heat inside. The location gives easy access from the main road and public toilets are available at suitable distances from the proposed area.

The general soil type is fertile alluvial soil up-to depths of 40 cm and the remaining layers below are of red soil.

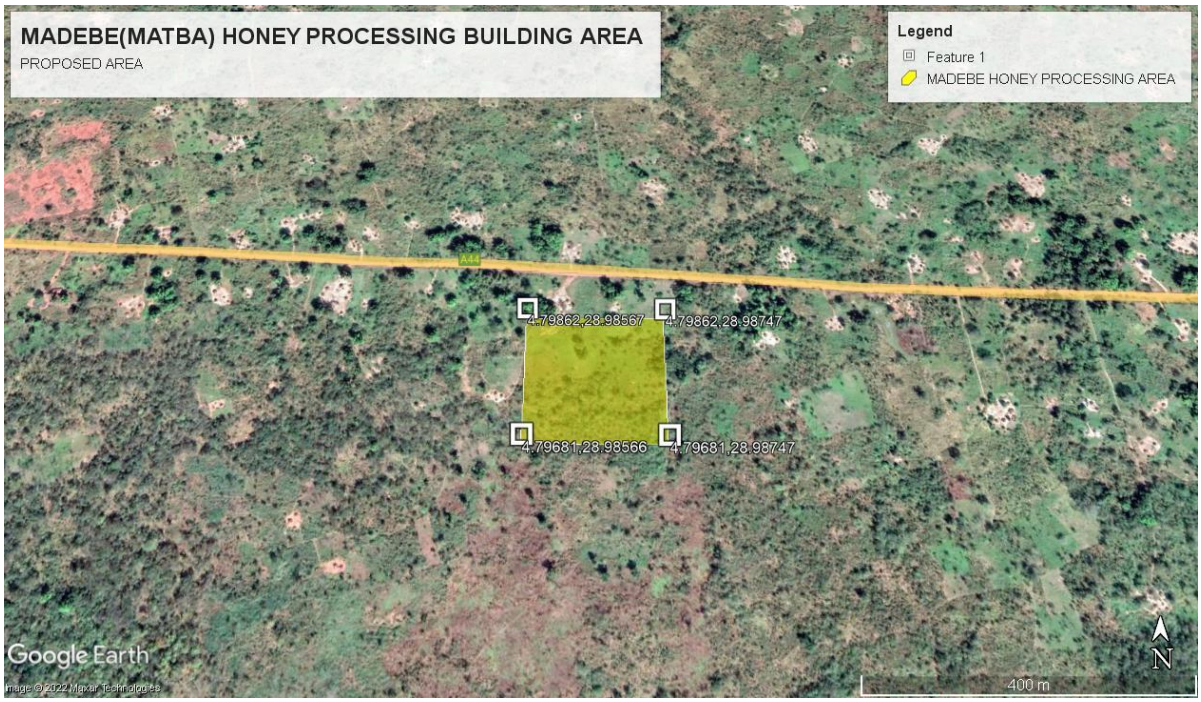
Fig 2.2 Medebe (Ibba) Honey processing Factory

The land size is 100m by 100m giving a total land area of 10,000m^2. The proposed site is located along the Maridi-Yambio road, on the left side the road coming from Maridi. The general soil type is fertile alluvial soil up-to depths of 40 cm and the remaining layers below are of red soil.

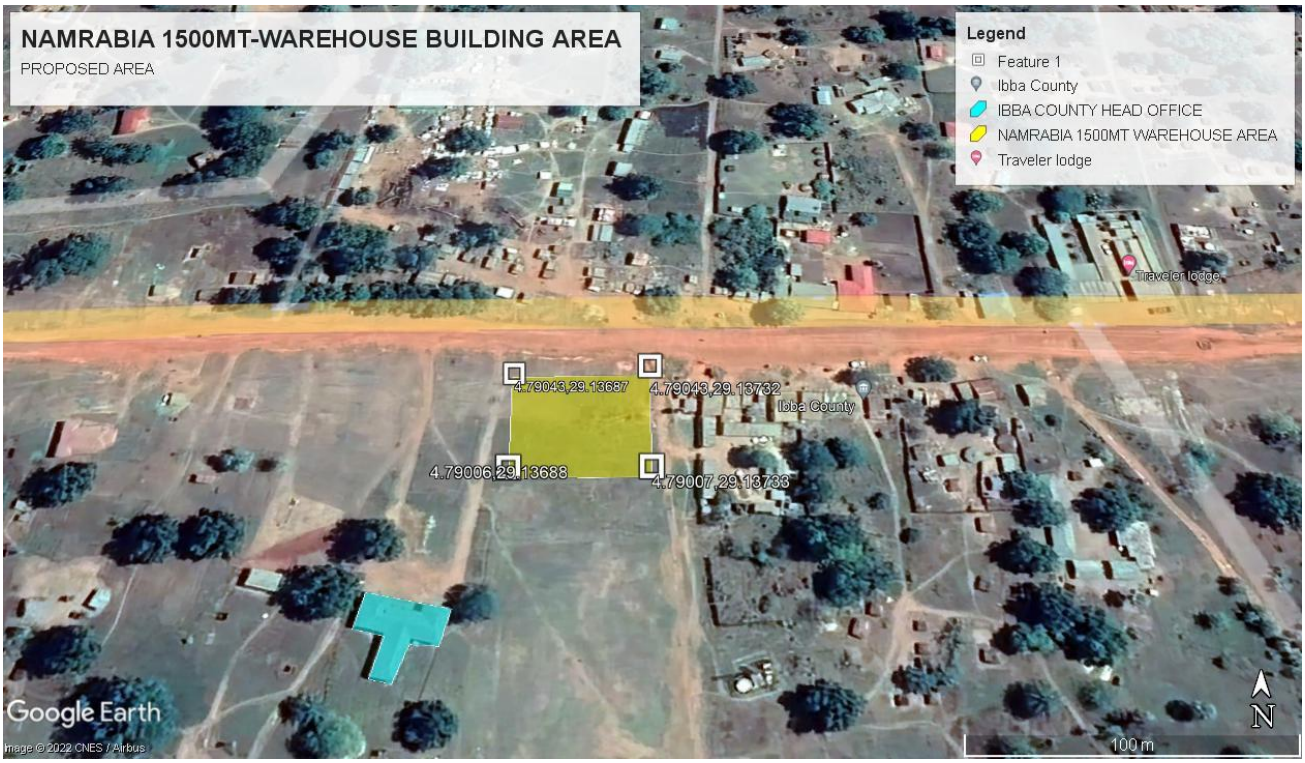
Fig 2.3 Namrabia (Ibba) 1500 MT warehouse

The size of the land allotted in Namarabia village is 40m by 50m giving total area as 2000m^2. There is human settlement in 33m from Ibba County Headquarters. The community of Ibba lives next to the area. A football playground is also next to the site. The proposed site is along the Yambio-Juba highway, which also goes to Central African Republic. The distance between the road and the proposed site is about 100m. The proposed land belongs to the government. Esu River located east of Ibba is about 1.8km and Ibba River to the West is about 1km. Ibba county plans to build a landfill to control waste for both warehouse and open market. The general soil type is fertile alluvial soil up-to depths of 40 cm and the remaining layers below are of red soil.

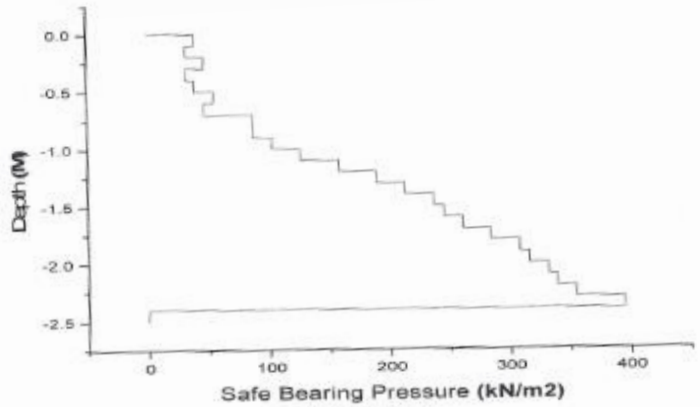
Geotechnical Investigation of 1500MT Warehouse Building in Namrabia,Ibba, South Sudan, Depth **-2.3M** (BC-355kN/m2) @ **(BH No.1)**

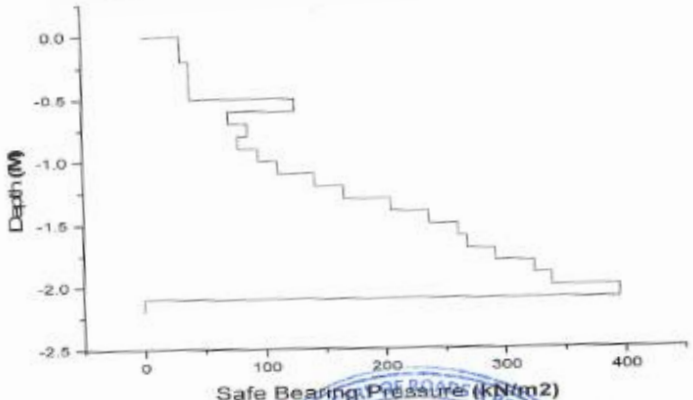
Geotechnical Investigation of 1500MT Warehouse Building in Namrabia,Ibba, South Sudan, Depth **-2.0M** (BC-339kN/m2) @ **(BH No.2)**

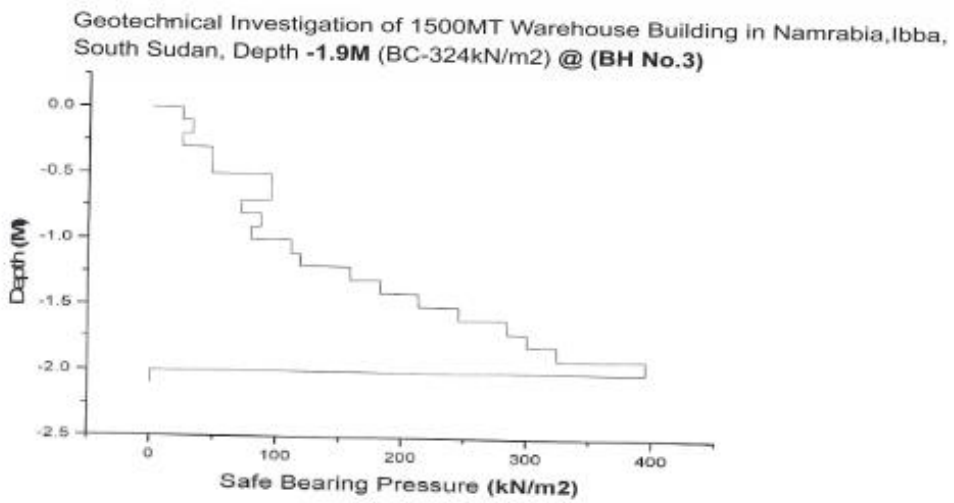
Geotechnical Investigation of 1500MT Warehouse Building in Namrabia,Ibba, South Sudan, Depth -1.9M (BC-324kN/m2) @ (BH No.3)
Depth (M)
0.0
-0.5
-1.0
-1.5
-2.0
-2.5
0
100
200
300
400
Safe Bearing Pressure (kN/m2)

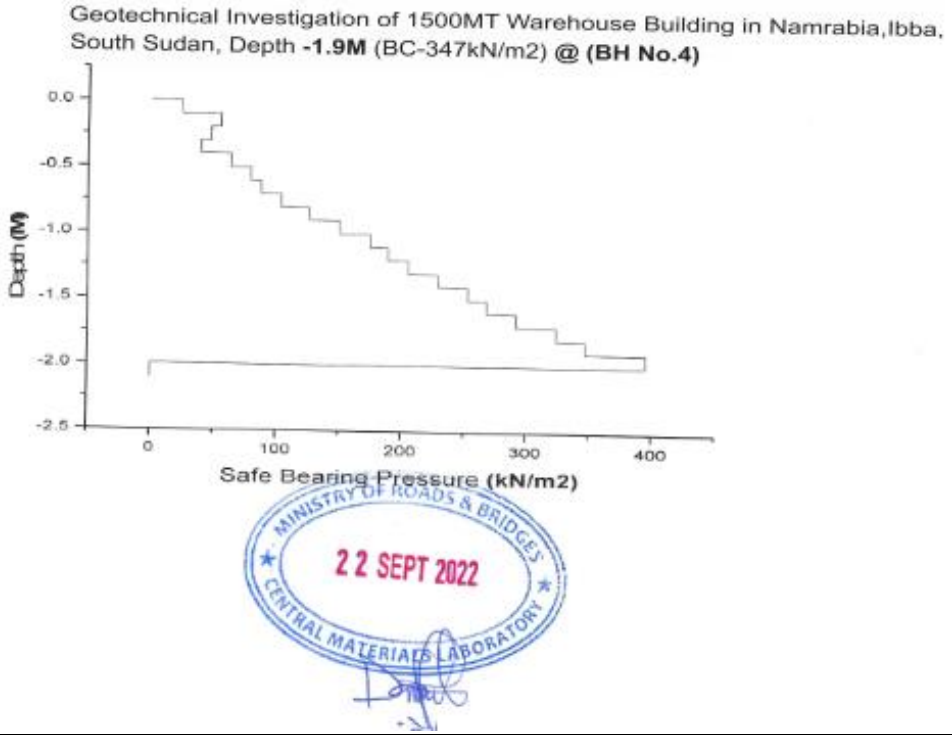
Geotechnical Investigation of 1500MT Warehouse Building in Namrabia,Ibba, South Sudan, Depth -1.9M (BC-347kN/m2) @ (BH No.4)
Depth (M)
0.0
-0.5
-1.0
-1.5
-2.0
-2.5
0
100
200
300
400
Safe Bearing Pressure (kN/m2)
MINISTRY OF ROADS & BRIDGES
CENTRAL MATERIALS LABORATORY
22 SEPT 2022

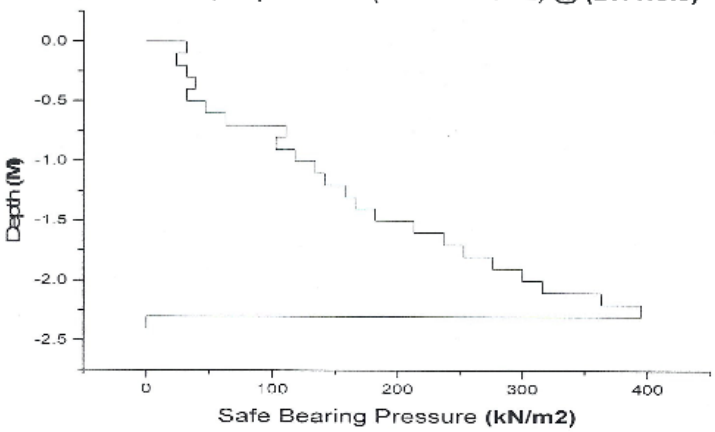
Geotechnical Investigation of 1500MT Warehouse Building in Namrabia,Ibba, South Sudan, Depth **-2.2M** (BC-363kN/m2) **@ (BH No.5)**

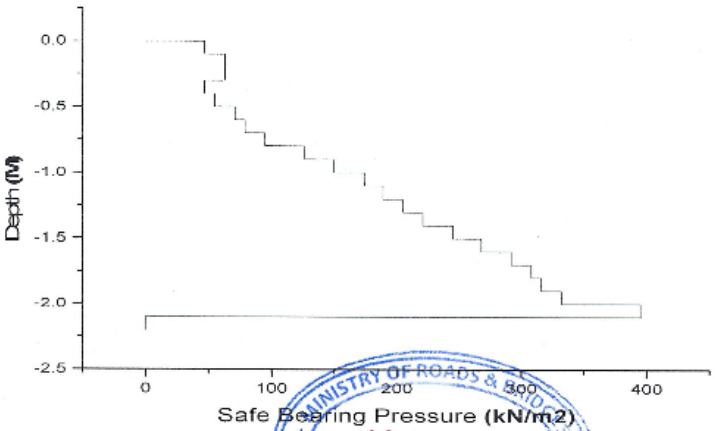
Geotechnical Investigation of 1500MT Warehouse Building in Namrabia,Ibba, South Sudan, Depth **-2.0M** (BC-332kN/m2) **@ (BH No.6)**
